Tiva™ C Series TM4C123x Microcontrollers Silicon Revisions 6 and 7

Silicon Errata

Literature Number: SPMZ849D
August 2013–Revised August 2014

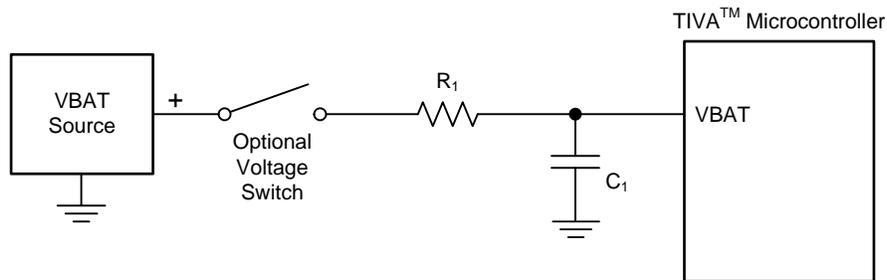
Figure 2. RC Circuit

ELEC#02 **V_{BAT} Supply pin may be Damaged if the pin Voltage Ramps Faster Than 0.7 V/ μ s**
Revision(s) Affected: 6 and 7.

Description The V_{BAT} supply pin may be damaged if the pin voltage ramps faster than 0.7 V/ μ s. Fast V_{BAT} ramps are a concern when a battery is being connected or the V_{BAT} supply is hard switched.

Workaround(s) An RC circuit as shown should be added to the V_{BAT} pin to prevent the damage. The R_1 and C_1 should be placed close to the microcontroller for best protection. In systems that do not require Hibernate when the VDD supply is off, the V_{BAT} pin should be tied to the VDD supply, which typically ramps at a rate slower than 0.7 V/ μ s. The R_1 and C_1 components are not required for a V_{BAT} supply ramp less than 0.7 V/ μ s.

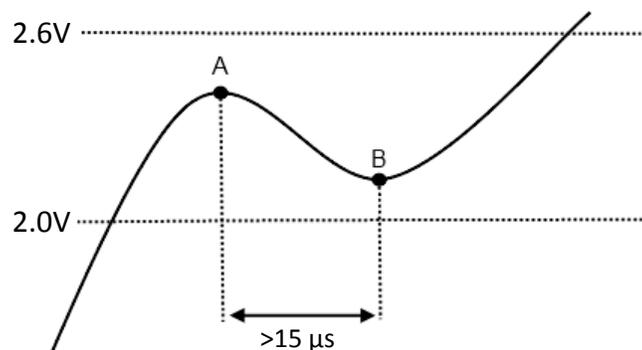
Figure 3. VDDA Waveform to Avoid Between V_{POR} min and V_{POR} max

Description: In very rare cases, a non-monotonic voltage rise of VDDA between the minimum and maximum Power-On Reset Threshold (V_{POR}) voltage range, 2.0 V and 2.6 V, can cause the on-chip LDO to not start up. Because the LDO controls the core voltage (VDDC), the device cannot start up correctly in this situation. If the LDO fails to start, power cycle the device until a successful power up occurs. A software or hardware reset cannot restart the LDO.

Workaround(s): A monotonic voltage rise of VDDA prevents this issue from occurring; however, a perfect monotonic ramp is difficult to achieve, particularly during LDO inrush. The risk of encountering this issue can be minimized by performing one of the following:

- If the VDD and VDDA pins are connected directly to the same power source, at every possible point A and point B along the VDDA waveform between 2.0 V and 2.6 V, point B must never fall below point A after 15 μ s, as shown in [Figure 3](#).
- Use a separate power supply for VDDA to reduce noise and isolate it from the effects of LDO inrush. At every possible point A and point B along the VDDA waveform between 2.0 V and 2.6 V, point B must never fall below point A after 15 μ s, as shown in [Figure 3](#). The separate power supply will make it easier to avoid this condition.
