Lessons from Field Damage Assessments about Communication Networks Power Supply and Infrastructure Performance during Natural Disasters with a focus on Hurricane Sandy

Alexis Kwasinski

Extended Abstract

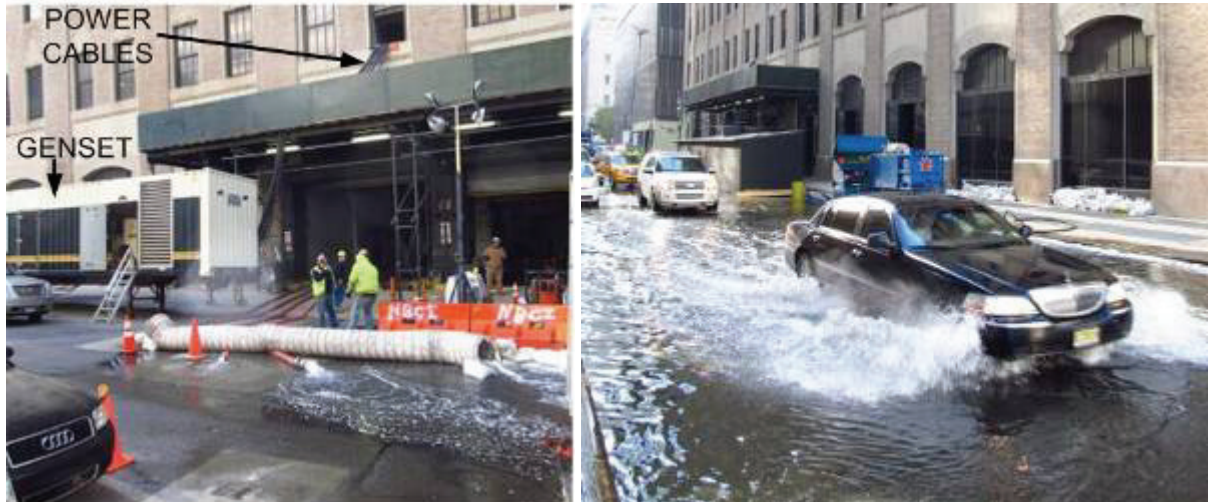
Fig. 4. Right: Water being pumped out and a diesel generator running at the entrance on Barclay Street for Verizon's main central office in Manhattan. Left: Flooding on Barclay St. from water being pump out of Verizon's central office at 140 West Street.

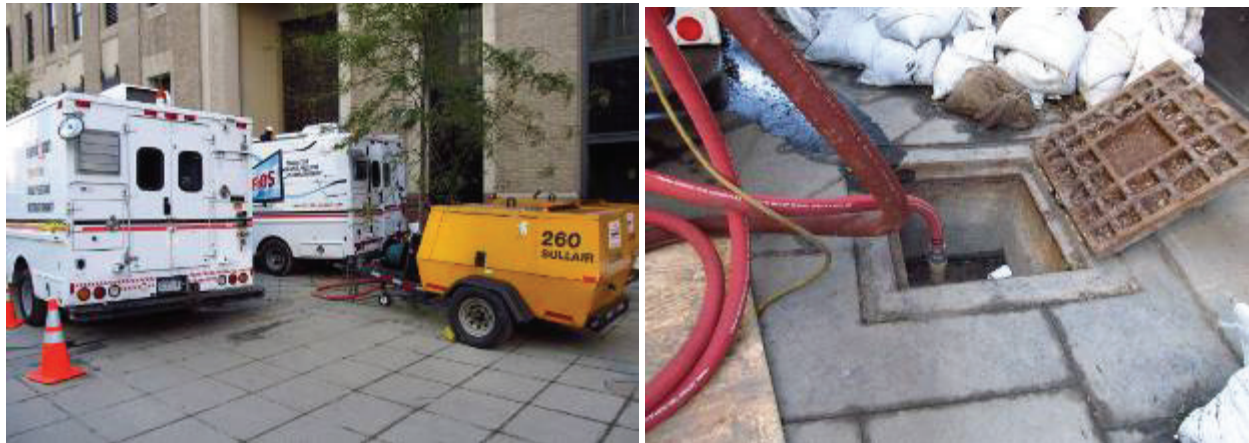
Fig. 5. Emergency cable pressurization units at 140 West Street. The image on the right shows the pressurized air injection nozzle.

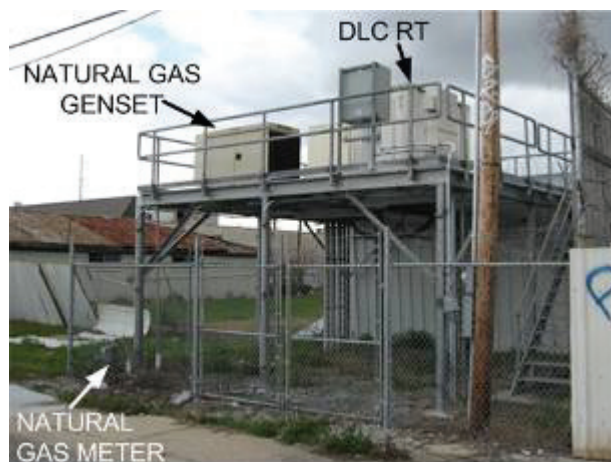
Fig. 6. A DLC RT in New Orleans installed a few months after Hurricane Katrina. Notice the natural gas generator.

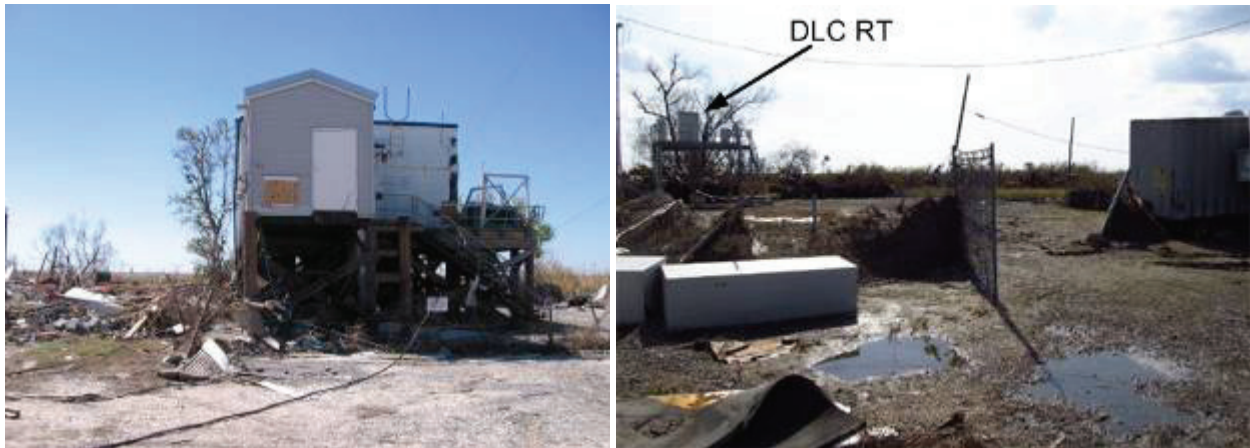
Fig. 7. Left: Remains of Yscloskey CO after Hurricane Katrina. Right: Same site after Hurricane Isaac

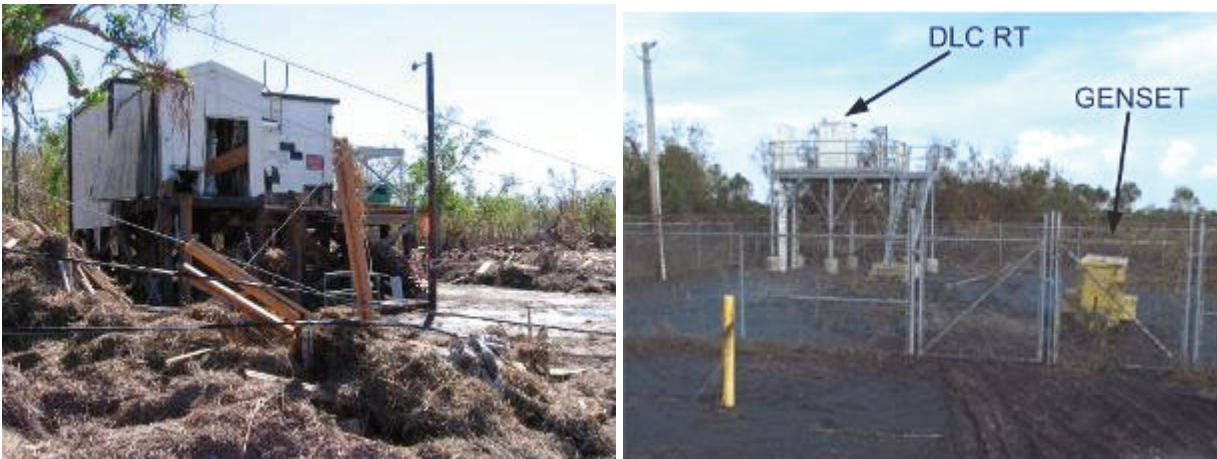
Fig. 8. Left: Remains of Delacroix CO after Hurricane Katrina. Right: Same site after Hurricane Isaac. Notice the yellow portable genset deployed to power the RT on the platform.

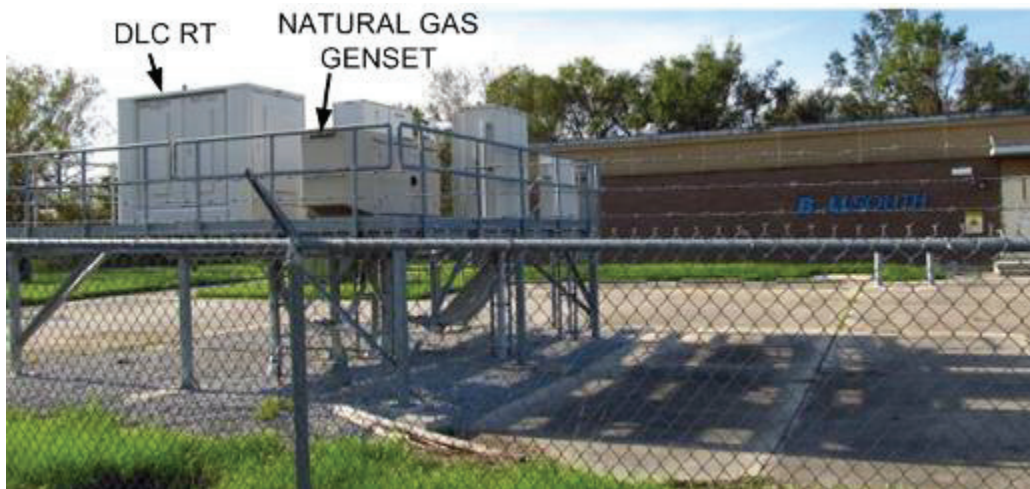
Fig. 9. In the background the building of Bellsouth's former St. Bernard CO flooded by Katrina. Equipment inside this building was never replaced and parts of its functions were restored with the DLC RT shown in the foreground and installed after Katrina.

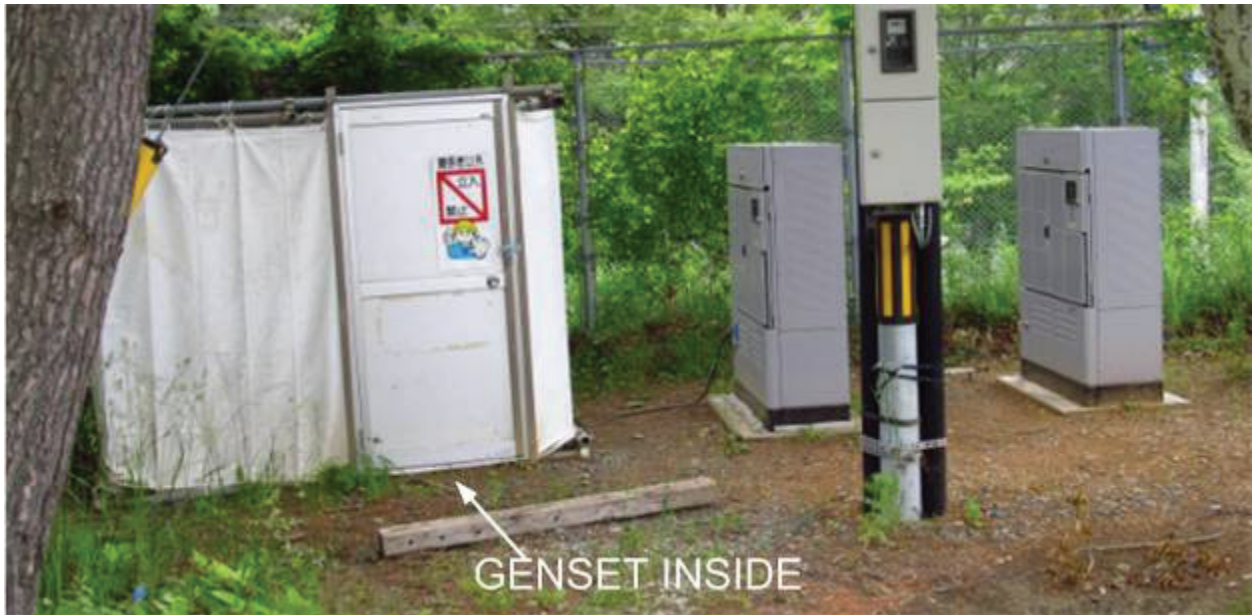
Fig. 10. Two DLC RTs uses to partially restore service in the area of NTT's Onagawa CO that was submerged by the tsunami.

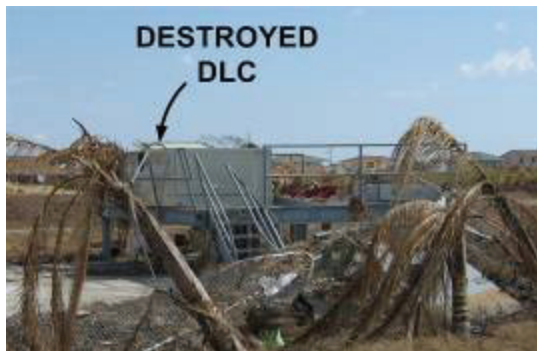
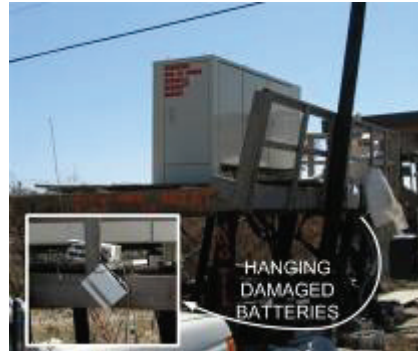
Fig. 11. DLC RT destroyed by Hurricane Ike. The one on the right had been installed after Hurricane Rita in order to partially restore service lost when Sabine Pass' CO was destroyed.

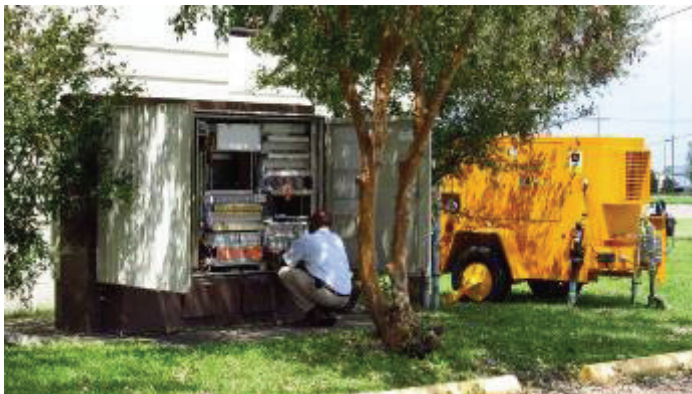
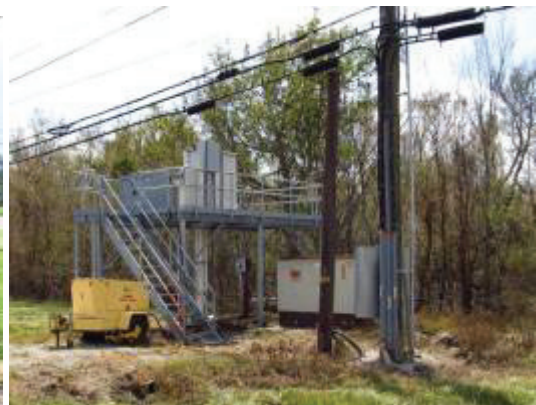
Fig. 12. Portable gensets deployed to power DLC RT after Isaac. The photo on the right shows both a pre-Katrina RT at ground level and a post-Katrina RT on a platform with a natural gas generator. It is unknown why a portable diesel genset was deployed at this site.

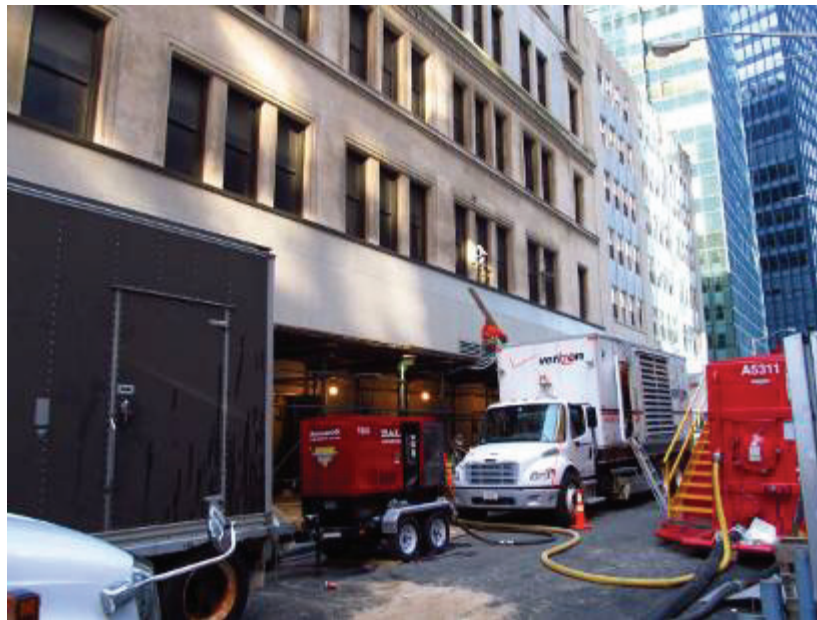
Figures 14 and 15 show the other central office that flooded in Lower Manhattan, this one located at 104 Broad Street. These two photos show mobile diesel generators on both sides of the building and two diesel trucks on the Water Street side. The damage assessment was able to identify two other central offices that may also likely flooded and had damage to power back up equipment: one in the Rockaway

Fig. 14 Pearl Street side of Verizon's central office at 104 Broad Street.

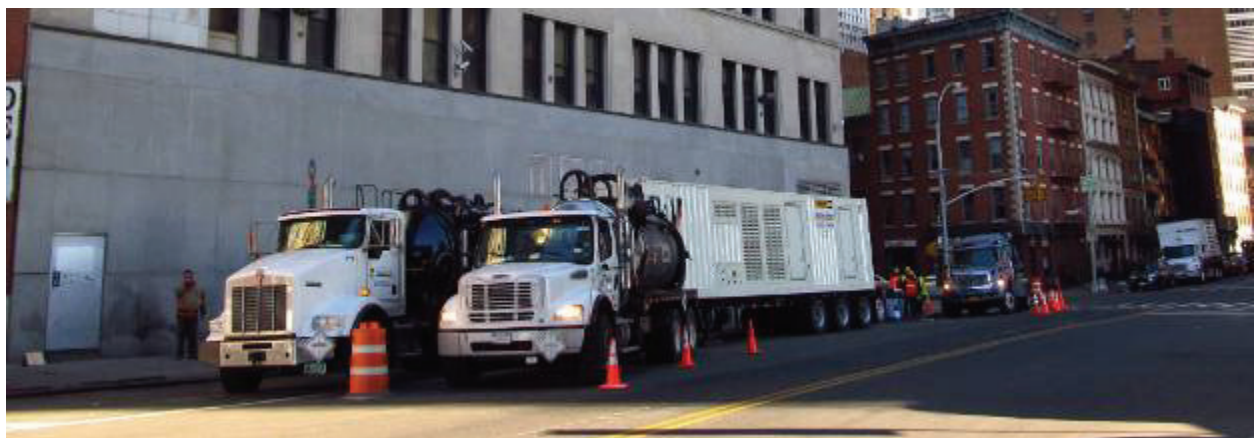
Fig. 15. Water Street side of Verizon's central office at 104 Broad Street.

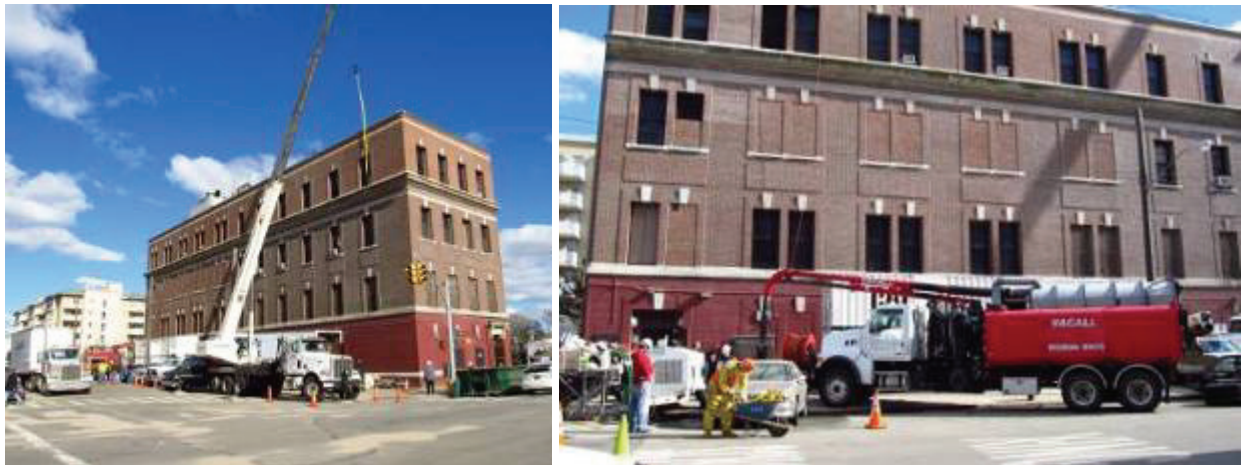
Peninsula (Fig. 16) and in Long Beach (Fig. 17 Left). All these four central offices likely experienced some loss of service.

Fig. 16. Verizon's central office at Rockaway Beach. The photo on the right shows a large portable genset behind the waste liquids vacuum pump.

Although Verizon attempted to prevent these sites from flooding by using sandbags, this solution seems to not have been very effective. Flood damage and loss of service could have been prevented in a number of other ways. One solution is to place onsite diesel generators and other power plant components, including fuel pumps, on higher floors. This was the design that likely prevented the central office at Lavallette (north of Seaside Heights) in Fig. 17 (Right) to have its diesel generator damaged even when Sandy's storm surge flooded the streets around the building. In some occasions, building structural resistance is mentioned as a concern when placing power plant components on higher floors. However, good construction practices prevent such potential structural issues. One notable example is shown in Fig. 18. These photos show the CO building in the town of Onagawa, Japan. Even when this CO was one of NTT's buildings located closer to the March 11, 2011 Mw 9.0 earthquake epicenter and was also completely submerged by the tsunami, Fig. 18 shows that there were no structural damage where the batteries were located, in the power room located on the first floor. Another good approach observed during the damage assessments in the aftermath of the March 11, 2011 earthquake and tsunami in Japan, is shown in Figs. 19 and 20 for the COs of Kamaishi and Unosumai, Japan. The figure corresponding to the CO in Kamaishi exemplifies a construction practice also observed in other COs: use of watertight doors. In addition, these and other CO are also surrounded by a wall with flood gates in order to provide limited flood protection for CO buildings. Although in some locations in Japan this design did not prevent damage from the tsunami because of its tremendous magnitude, watertight doors and flood gates reduced the damage in Kamaishi and other locations [6] and it would have prevented flood waters to enter the aforementioned buildings affected by Sandy. All other visited central offices in the affected area did not show flood damage, mostly because significant flood waters did not reach other sites and sandbags protected the building from the limited potential flood waters that reached those other building (Fig. 21). The only other central office that requires a special mention is the one in Fig. 22 in Garden City. This central office has seven 200 kW fuel cells that can power the facility when fueled by natural gas. When this site was visited on November 3, there was still no commercial power on, yet this site showed no signs of being out of service suggesting that the fuel cells or other onsite generation means were operating adequately.

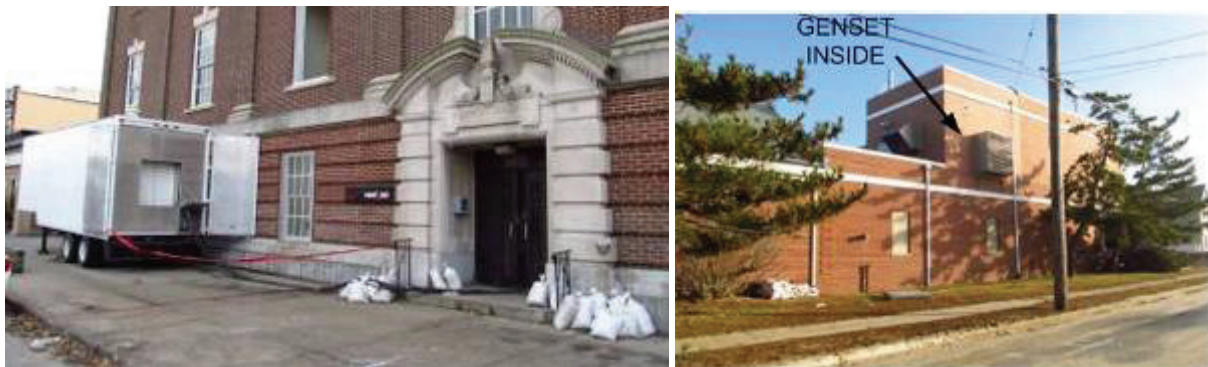
Fig. 17. Left: Verizon's central office in Long Beach. Right: Verizon's central office in Lavallatte. Notice the genset located on the second floor.

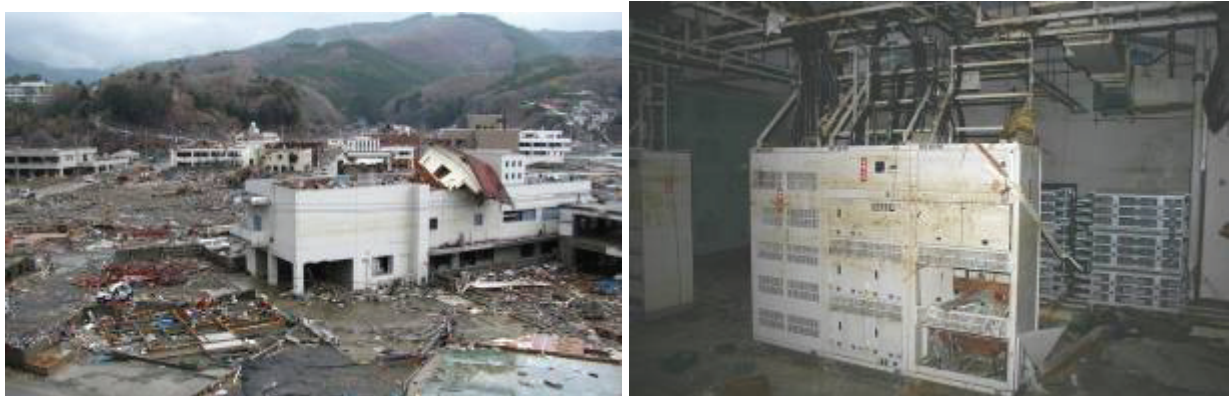
Fig. 18. Onagawa CO Building. Left: Exterior. Right: Interior; power room.

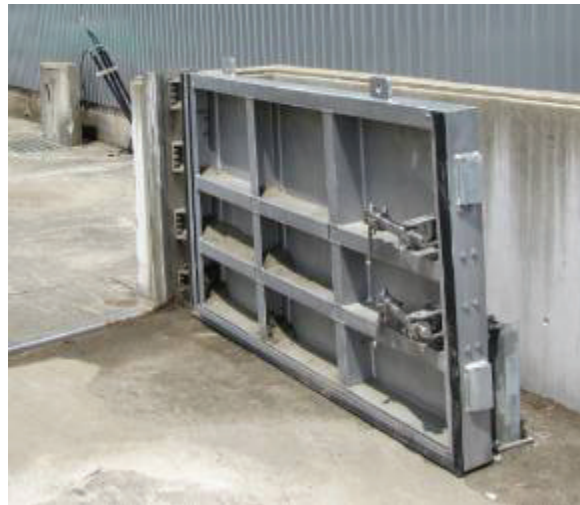
Fig. 20. Flood gate in Unosumai central office, Japan.

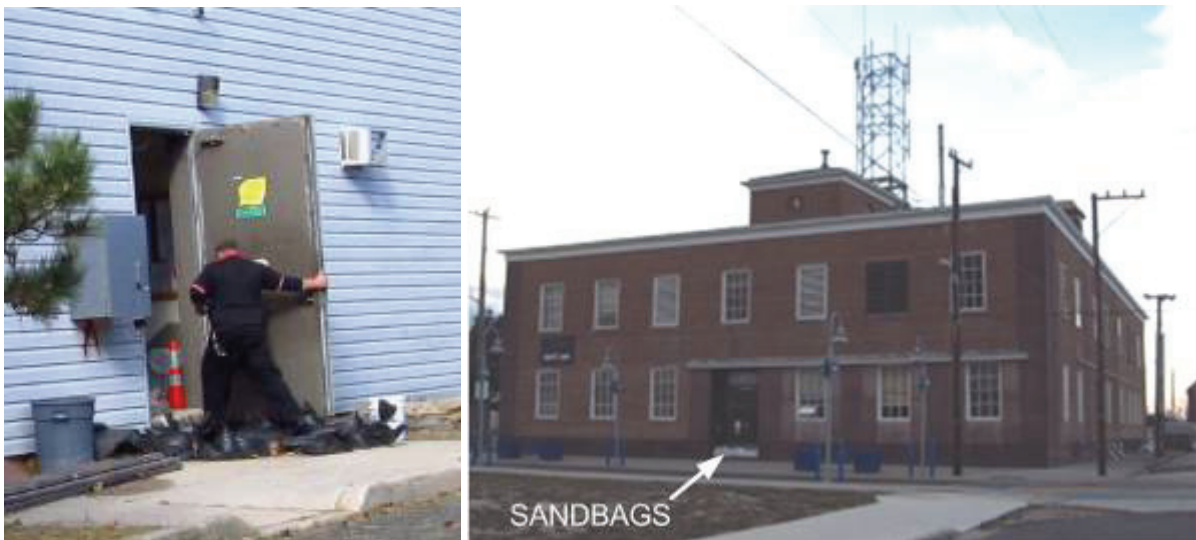
Fig. 21. Verizon's central offices in Brigantine (Left) and Wildwood (Right). Notice in both cases the sandbags at the doors.

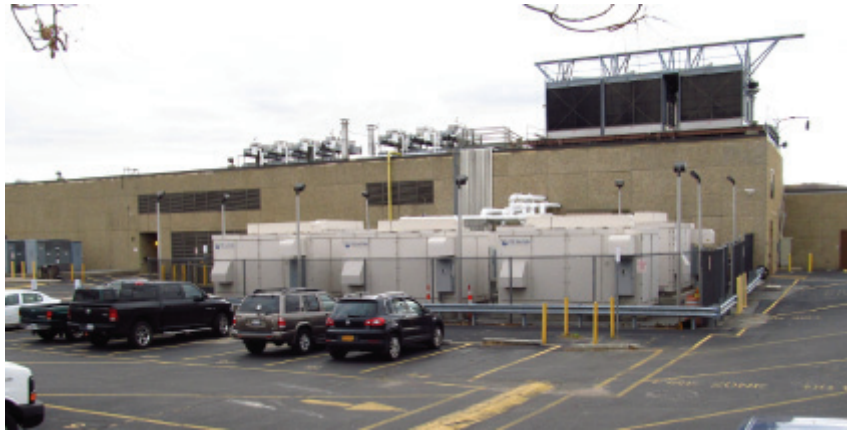
Fig. 22. Fuel cells at Verizon's central office in Garden City.

Although these local sources make microgrids to be a relatively costly solution, for high-power loads, such as COs, microgrids are cost competitive with respect to conventional power solutions. Moreover, use of absorption chillers in combined-heat and power cycles addresses the aforementioned cooling circuit low availability problem [10]. As a result, with an adequate design and planning, microgrids could reach availability levels of 6 nines or higher [13] [14]. To date, two microgrids operated by communication network provides, one in Sendai and the other in Garden City (Fig. 22) have operated satisfactorily during natural disasters.

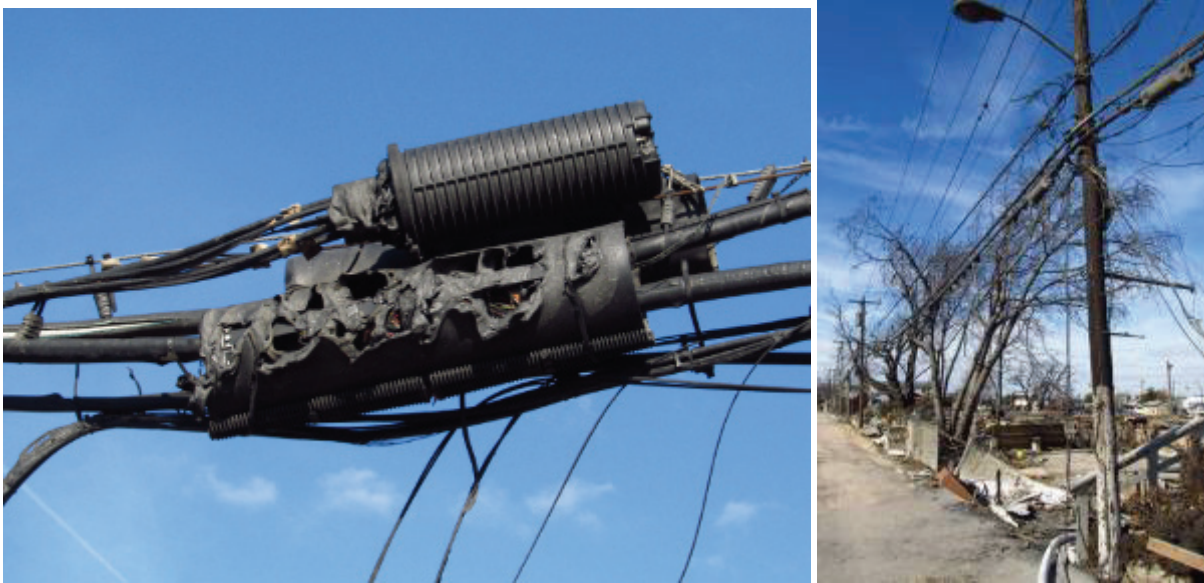
Fig. 23. Damage from a fire affecting communications infrastructure.

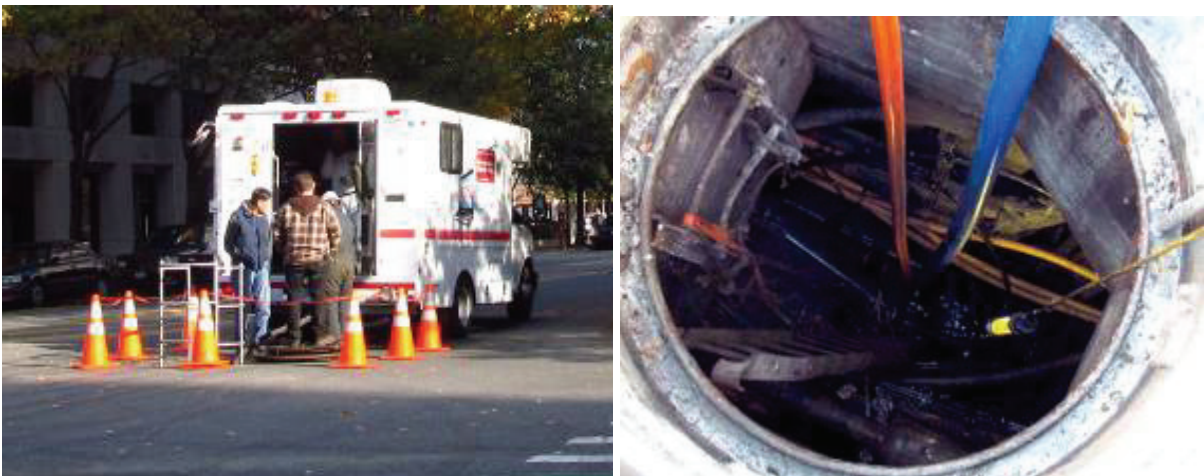
Fig. 24. Left: A Verizon's truck working next to manhole. Right: A manhole still with water.

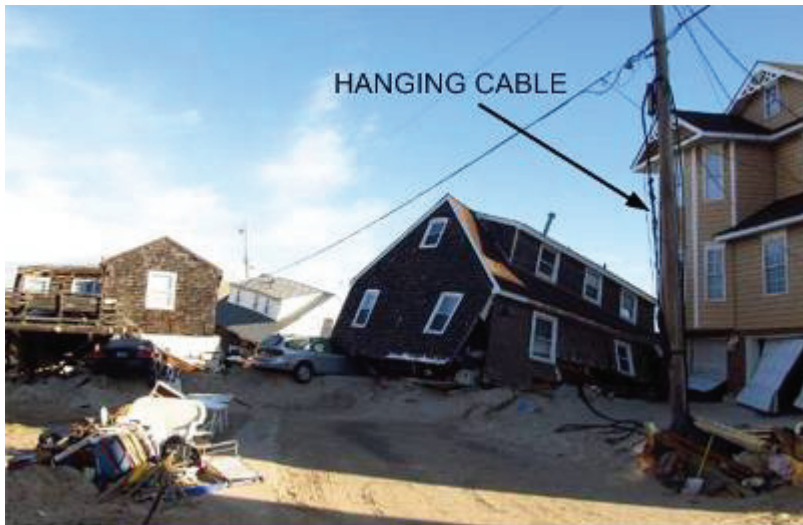
Fig. 25. A severed telecom cable hanging from the pole on the right.

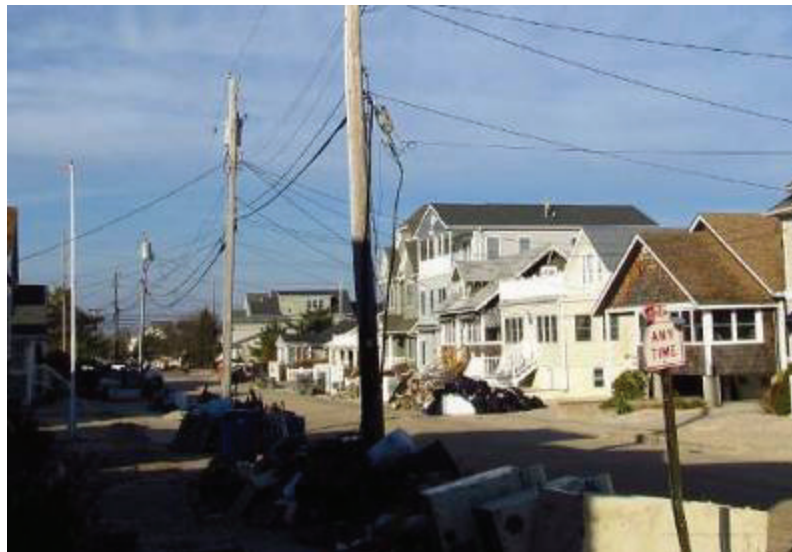
Fig. 26. Damage to the pole nearest the sea in Ortley Beach

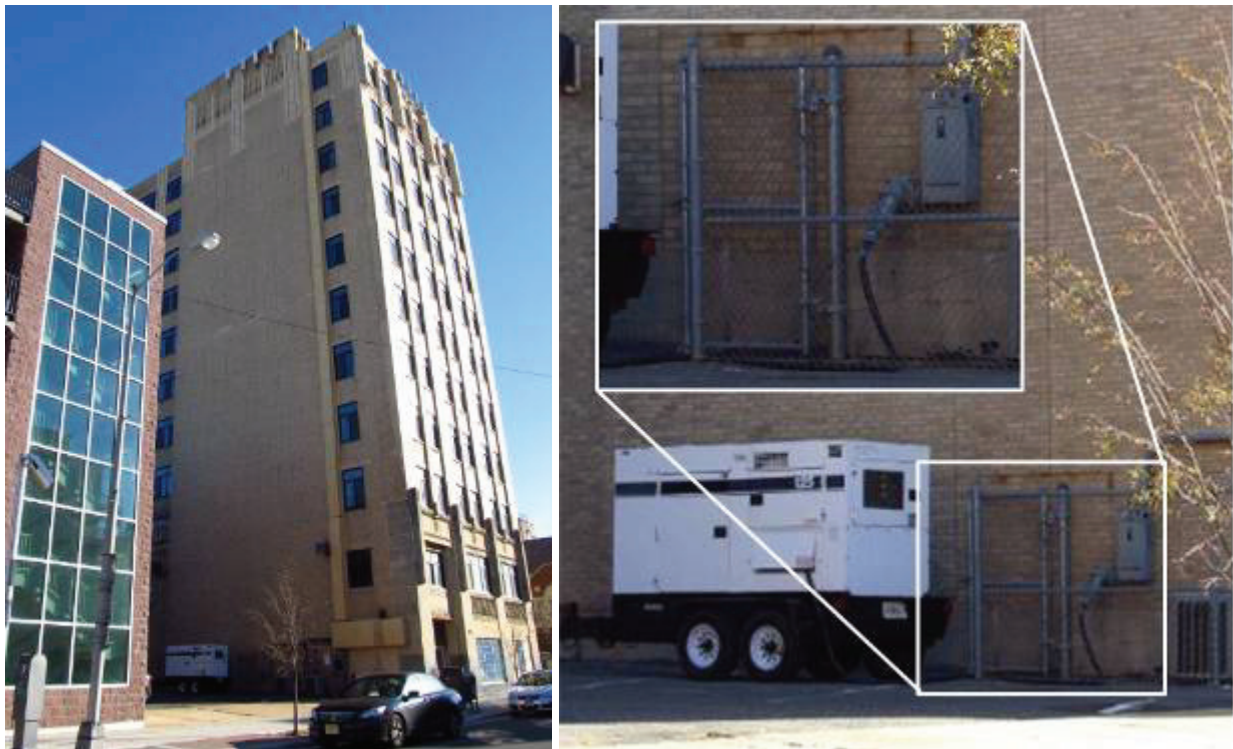
Fig. 29 A rooftop cell site in Ausbury Park powered by a genset at street level. Notice the standard connector for the genset.

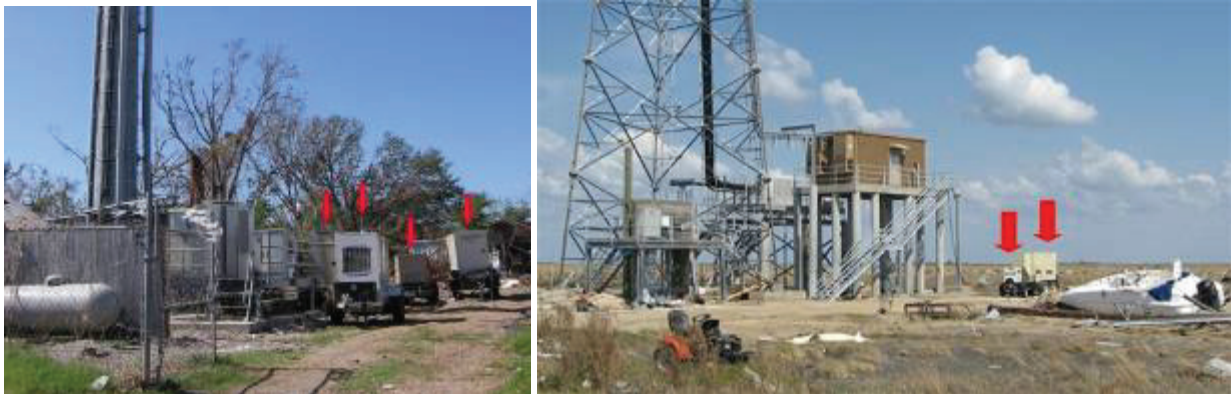
Fig. 32. Multiple portable gensets deployed to cell sites in the aftermath of hurricanes. Left: Katrina. Right: Ike.

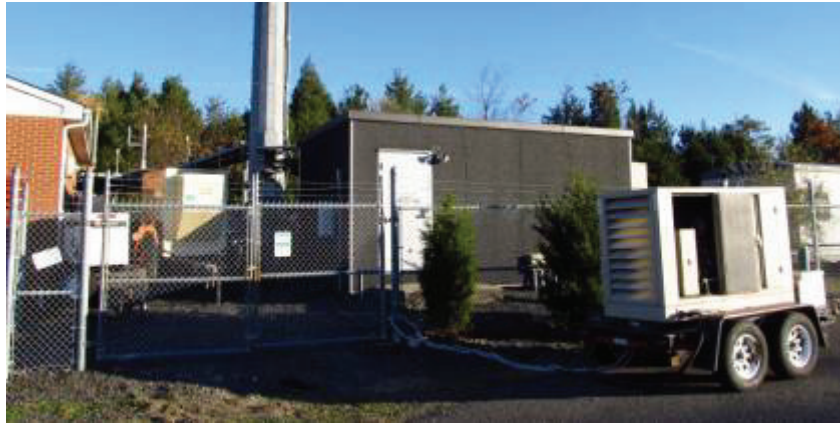
Fig. 33 A cell site with multiple genset (3 portable and one permanent) at the intersection of I-95 and I-195 in New Jersey after superstorm Sandy.

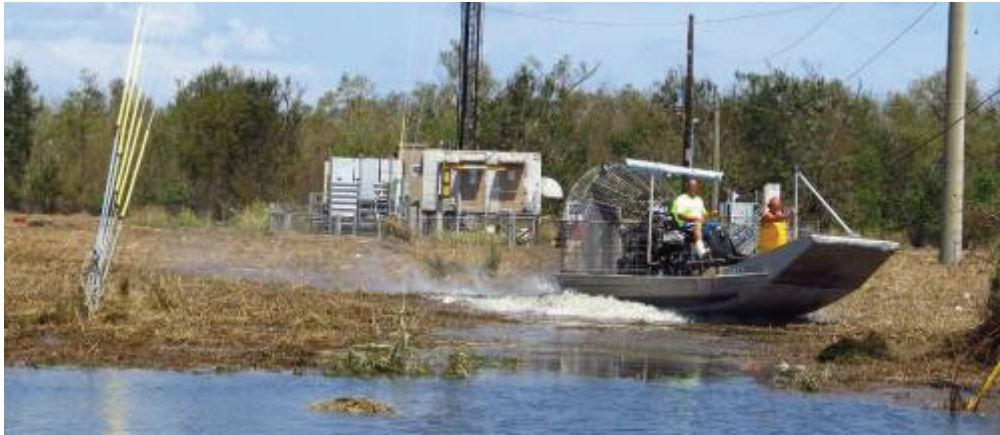
Fig. 34. Flooding around a cell site near after Hurricane Isaac.

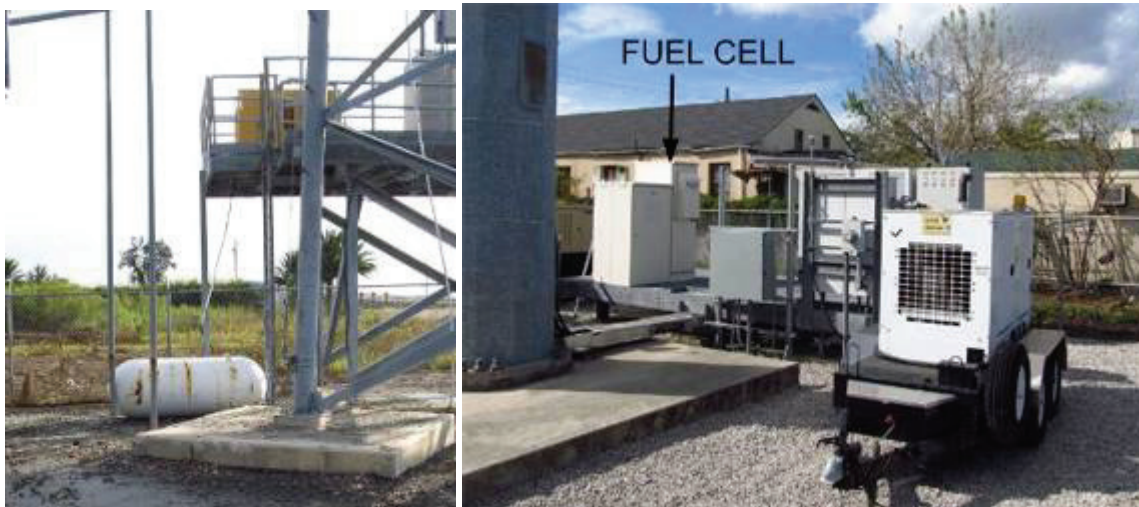
Fig. 35. Power backup alternatives for cell sites in the aftermath of Hurricane Isaac. Left: Propane tank damage by Isaac's storm surge. Right: Fuel cells.

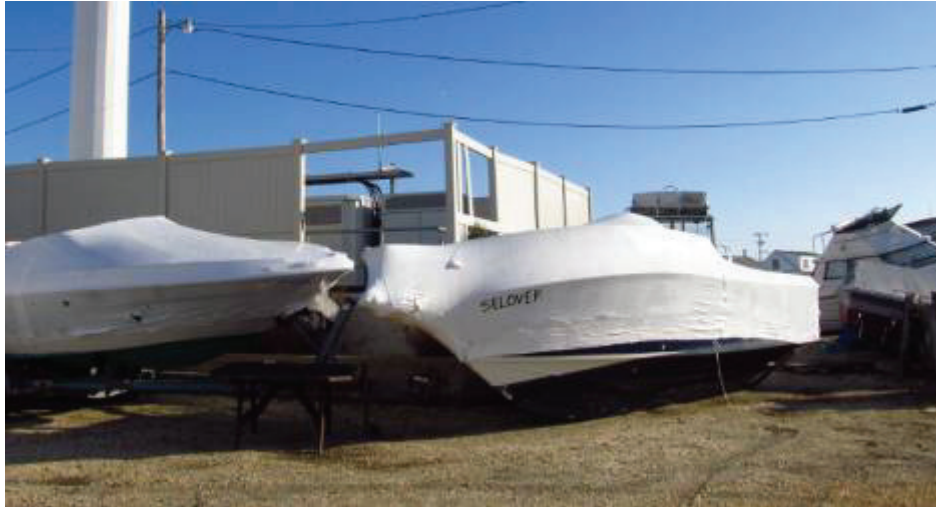
Although with Sandy most cell sites power issues, some, like the one in Fig. 36 may have been damaged by storm surge. This photo exemplifies a construction practice difference between the northeast Atlantic Coast and the Gulf Coast: in the former region base stations that are not located on building rooftops are not placed elevated above the flood plane as it is done in many cells sites of the Gulf Coast. Still, it is possible to observe that in the Gulf Coast this practice is not followed uniformly because it is also possible to find cell sites like those in Fig. 37 where base stations had been placed at different heights.

Fig. 36. A cell site in a marina near Seaside Heights. The boats were scattered around by Sandy's storm surge.

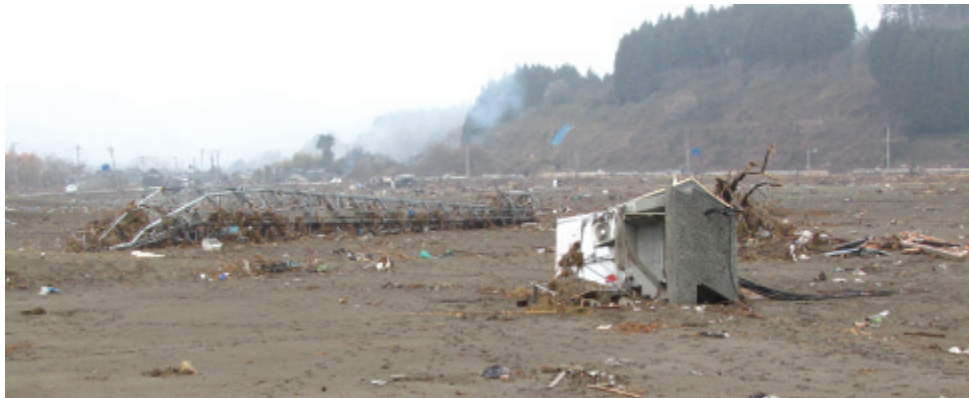
Fig. 42. A cell site in Rikuzentakata, Japan, destroyed by the March 11, 2011 tsunami.

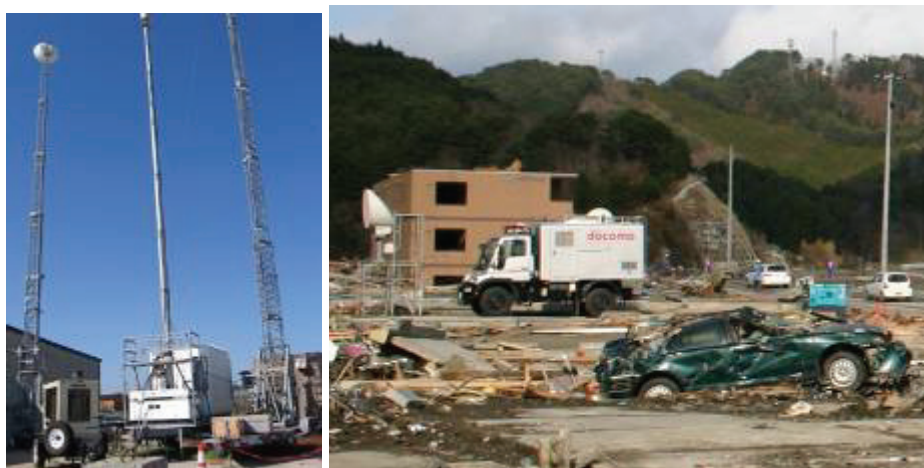
Fig. 43. Microwave repeater units linking cell sites. Left: in Biloxi, MS after Katrina. Right: in Otsuchi, Japan, after the March 2011 tsunami.

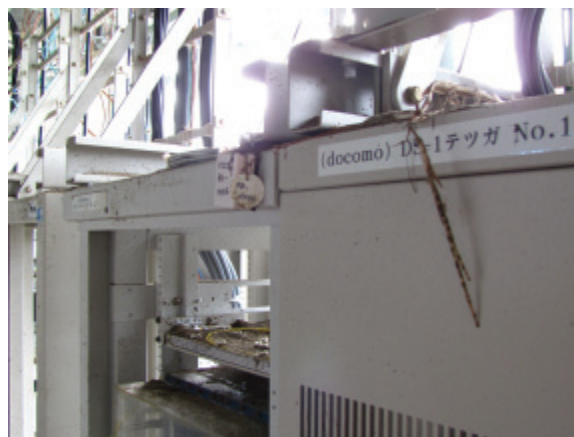
Fig. 45. NTT Docomo (wireless) switching equipment at NTT East's (wire-line) Nobiru CO.

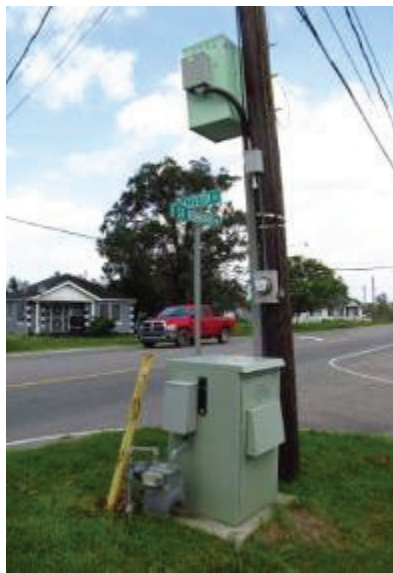
Fig. 49. A pad mounted natural gas generator powering CATV equipment after Hurricane Isaac.

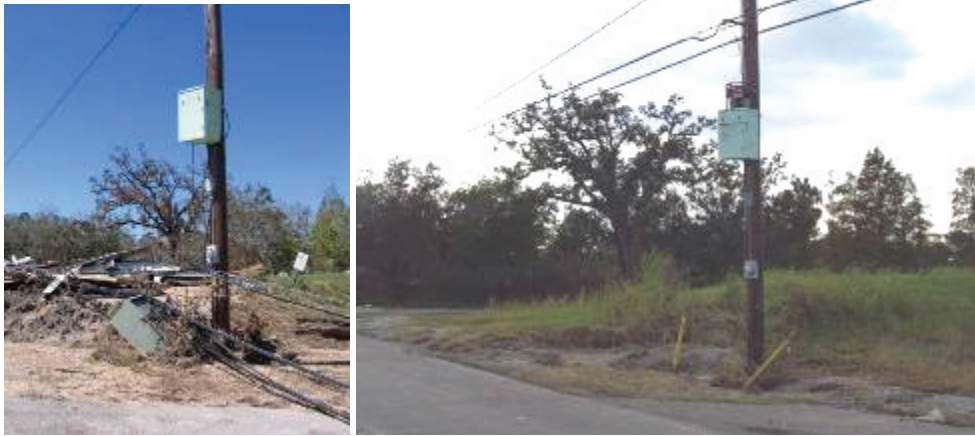
Fig. 50. Left: A pole mounted CATV amplifier and power supplier with a pad mounted natural generator destroyed by Katrina's storm surge. Right: The same CATV equipment after Isaac powered by a camping portable genset placed on top of the CATV amplifier and power supply

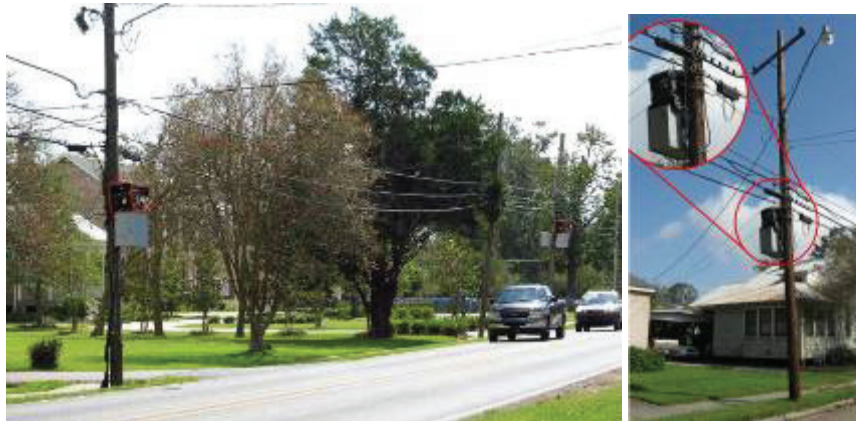
Fig. 51. Examples of camping-type portable gensets used to power CATV pole mounted equipment. Left: After Isaac. Right: After Gustav.

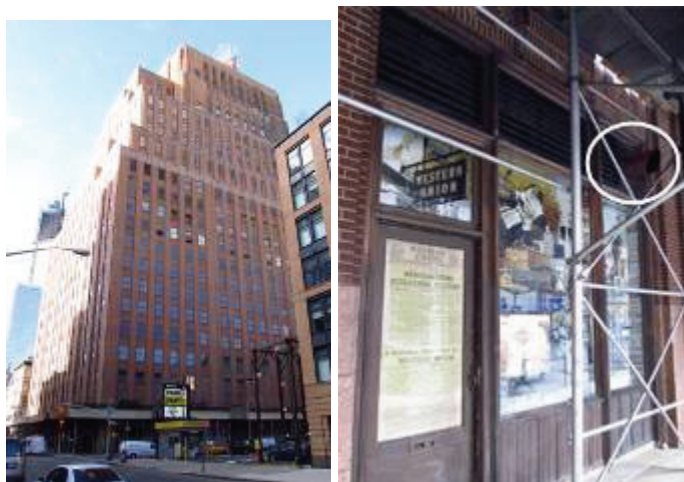
Fig. 53. Data center at 60 Hudson Street. Notice the diesel generator exhaust on the photo on the right.

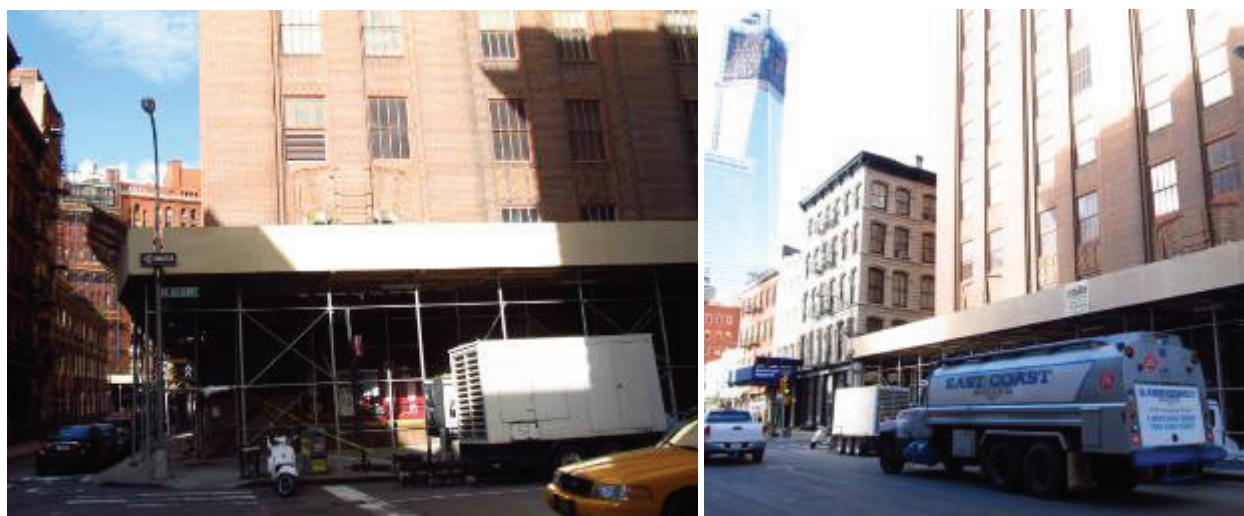
Fig. 54. Two views of the 60 Hudson Street data center showing additional small gensets in the area and a truck with diesel to replenish the fuel tanks at this site.

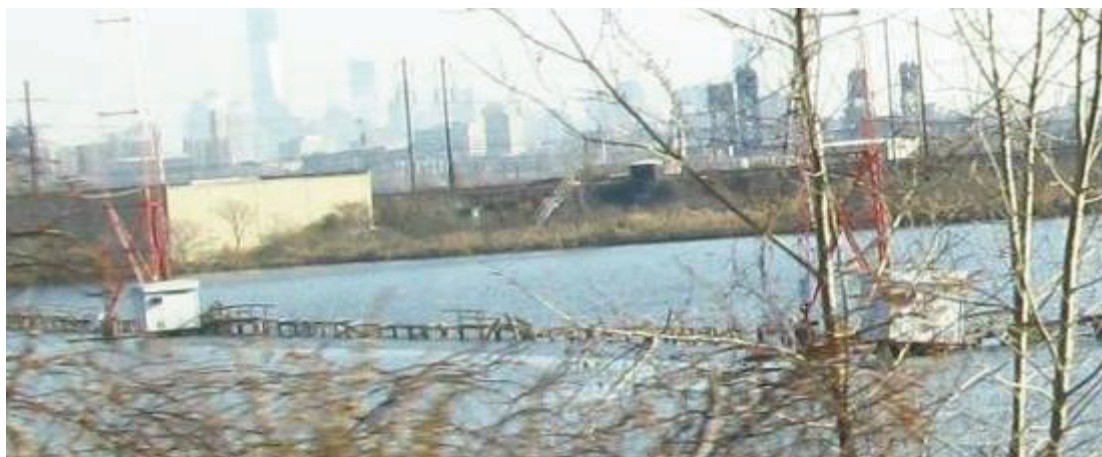
Broadcasting networks (radio and TV) also experienced service affecting issues during Hurricane Sandy. One example is shown in Fig. 55 where the site with the transmission towers was flooded and the huts with the transmission equipment were damaged.

Fig. 55. Transmission towers for WEPN, damaged by Sandy.

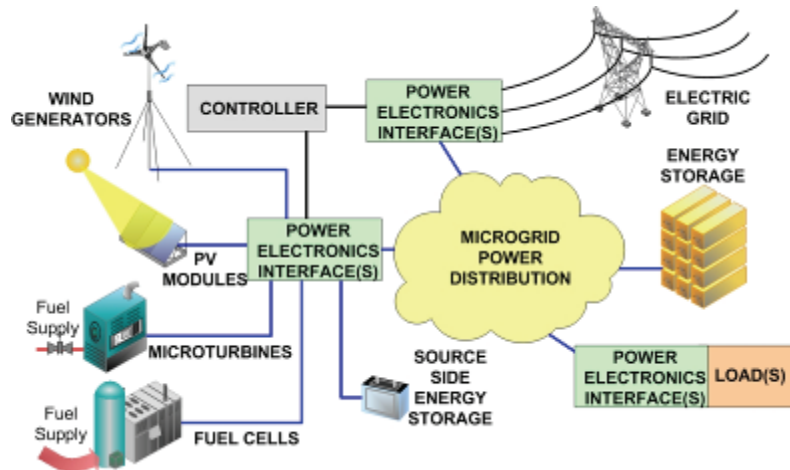
Fig. 60. Representation of a microgrid showing its main components.

The alternative to address power grids fragility through power grid-based approaches is to implement solutions at the network operators' level. The conventional approach implemented by network operators is to still rely on backup power plants and increase diesel storage tank capacity and/or battery backup time. But, as it was discussed, these solutions are also limited. For example, adding batteries does not improve the availability of the cooling circuit so outages due to high temperatures equipment shut down are equally likely, as it is verified by cases of CO outages during the 2010 earthquakes in Haiti and Chile where at least one CO in each event failed due to cooling issues. The more modern approach that could be implemented by network operators is to power communication sites with microgrids, such as those introduced in [11] and [12]. As it is represented in Fig. 60, microgrids are independently controlled and confined power grids with their own local power generation sources. These local power sources are the main power source of the microgrid and when they are combined with a local controller, allows the load—i.e. the communications equipment—to be powered independently of the power grid condition. Although the power grid can be used as a power source for the microgrid, it is a secondary power source.
